Internal Rear View Mirror "Isabella"

F I L E R
PKW 1
 F I L E G R O U P
50-64
 B U L L E T I N
2
 N U M B E R

Bremen, Germany, November 16th, 1959

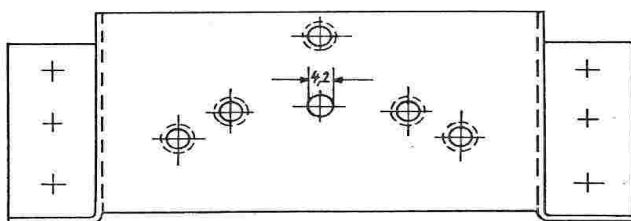
Bracket for rear view mirror

It was ascertained that under certain conditions, especially on bad roads, the internal mirrors of some cars of above mentioned type have a tendency to vibrations. The reason for this vibration has been found in the meantime, which can be easily rectified by the following procedure:

1. Remove rear view mirror and parapet batten.
2. Remove headliner till mirror bracket is exposed.
3. Scribe additional bore according to sketch on mirror bracket and cowl panel and drill (4.2 mm or .17" \varnothing).
4. Connect mirror bracket with cowl panel by button head countersunk bolt M 4 x 30 with hexagonal nut M 4.
5. Attach headliner. Refit parapet batten and mirror.
