Body BORGWARD "Isabella"

Carl P.W. Borgward G.m.b.H.
Service Dept. - Technical Service

Bremen, Germany, October 25th, 1960

Body BORGWARD "Isabella", October 25th, 1960

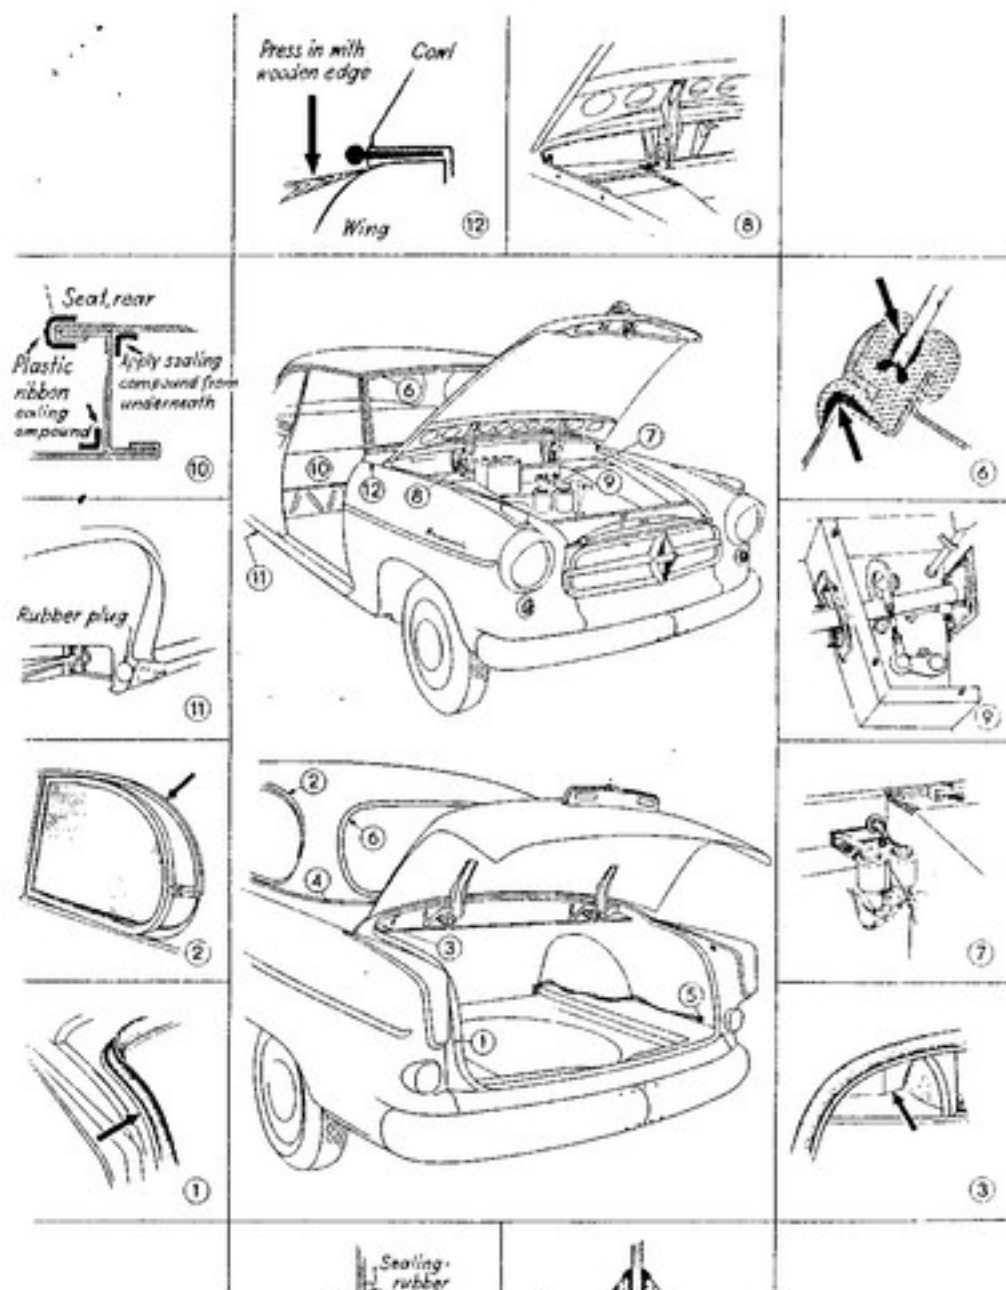
1. Check if the rubber profile for the sealing of the trunk compartment is completely and firmly glued on (fig. 1).
Rectification: Glue on rubber profile anew.

2. The sheet metal-U-profile for the support of this rubber seal shows towards the wing side porous holes or cracks (see arrow fig. 1).
Rectification: Smear suspected leaky spots with sealing compound.

3. Water entrance on the roof guttering on the roof by cracking of the burning-off seam (fig. 2). The outlet above the rear left hand side window is especially critical. Smallest porous apertures or cracks in this area can be the cause of water entrance. The water collects then upon the reinforcement plate in the rear upper trunk compartment and flows over from there into the trunk compartment (fig. 3).
Rectification: Remove ornamental batten and weld the suspected leaking spots.
Weld autogenous and use the smallest welding burner for sheet metal welding.
Cover up the surrounding areas against heat extension by using asbestos plates or pulp soaked in water.

4. Water collects as under position 3 on the rear reinforcement plate in the trunk compartment. Water can enter under the rear parapet batten due to a missing sealing rubber on the holding screws. By removal of the cover plate which is located above the reinforcement plate (with mounted foam rubber) (fig. 3 arrow) the leaky spot can be traced by spraying a water jet on the parapet batten. At the same time observe with the aid of a flashlight where the water enters.
Rectification: Leaky spots are coated from the inside with sealing compound, using a long brush and in case the sealing rubber under the parapet batten is missing, this must be fitted.

5. Water enters into trunk compartment at the cable duct for the brake light (fig. 5).
Rectification: In case that the cable is too tight it

6. The reasons mentioned under position 3 and 4 for the water entrance into the trunk compartment can also cause a soaking of the roof lining between rear window and rear side window. Furthermore, care must be taken that the rubber profile frame rests properly against body and window. Seal leaky spots with window cement (fig. 6).

- a) heater cable
 - b) pedal bracket (fig. 7)
 - c) heating duct (fig. 7 and 8)
 - d) bulkhead plate (spray under wings)
 - e) brackets for accelerator pedal

- f) flange of the guide tube for hand-brake (fig. 7)
 - g) bearing bracket for bonnet (fig. 8)
Rectification: All above mentioned leakages can be rectified by application of sealing compound!

9. Water entrance on bearing plate for steering on front wall (protecting box) (fig. 9).
Rectification: Remove plate for gearshift in front of covering box and smear plate as well as screws with sealing compound. This water entrance is frequently caused by water dripping from the main harness on to the bearing plate. To prevent this leakage the main harness should sag.

10. The floor plate which rises by steps under the rear seats is spotwelded with a vertical standing sheet metal traverse over the total width of the car. In case that water enters here, the floor mats before the rear seats are wet (fig. 10).

11. Carpet in front of rear seats is wet. Water can enter between the box for the car jack in the sill bracket and connection to cross member (rear) (fig. 11).

Rectification: The upper joint of both plates below the rear seat is covered with a plastic ribbon. Inside the car the connection of the vertical plate to floor plate is also covered full width with sealing compound. From the bottom side the plate connection in full width must be sealed with sealing compound (also underneath the wings as well as in the corners and at the flange between bearing plate for triangular strut with the cross member). Observe also position 11!

Rectification: For this purpose remove rubber plugs from wheel house and apply sealing compound to edges of box for car jack with a long brush.

Rectification: Press in plastic ribbon between rubber seal and wind respectively cowl with a wooden edge (fig. 12).

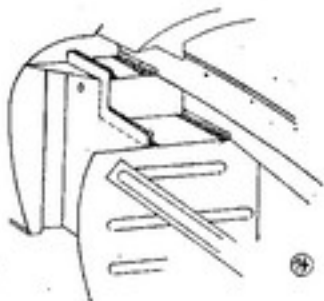
14. Water entrance between door and front wall

- a) - on cable lead-in for interior light.
b) - on the upper edge between front wall and front wall side part.

- a) Remove bulkhead and fit cable in sagging position.
b) Smear edges (fig. 14) with sealing compound (supplements pos. 12).
