Technical Tips No.1

Removing a Horn Button Assembly

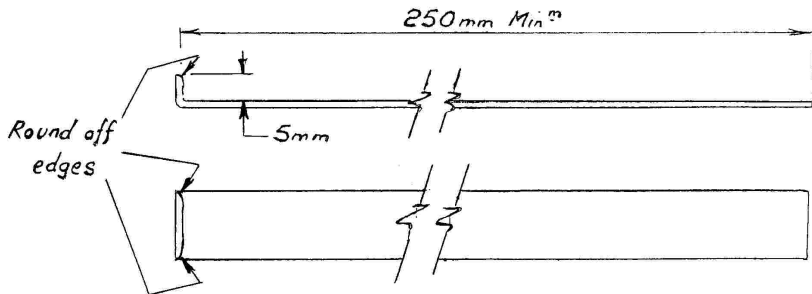
Too often, the horn button chromed retaining bezel or, the adjacent part of the steering wheel get unnecessarily damaged by attempts to prise out the Horn Button Assembly with a screwdriver or similar instrument. This damage can be avoided by making a very simple tool. A strip of metal with the end bent over.

The above strip was made from 2mm thick, 15mm wide, aluminium. It could be made of steel of thinner gauge. The width is not critical either, but the strip should be wide enough to distribute the weight of the hammer taps without marking the bezel. Round off the edges as indicated to also avoid marking the bezel.

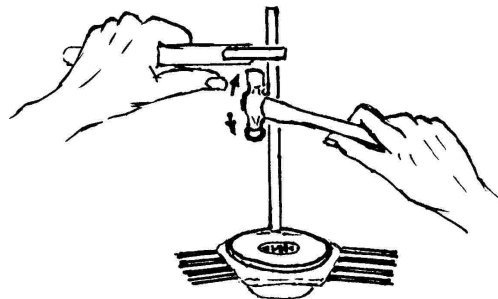
The strip is held in 'Mole' grips and the folded end hooked under the inner circumference of the chromed bezel. The folded end is then worked around the circumference whilst at the same time, the grips are gently tapped with a light hammer in an upward direction. Progressively, the Horn Button Assembly will be lifted out of its recess unmarked. If the bezel is particularly tight due to long standing, oil the interface between the bezel and the steering wheel with light oil.
